Implementing and Field Testing a Solar Photovoltaic System at a Palestinian Village

A report to Greenstar Foundation by

David Berman and David Faiman, Ben-Gurion University
Ibrahim Yehia, Sol-Nur Enterprises
September, 1999

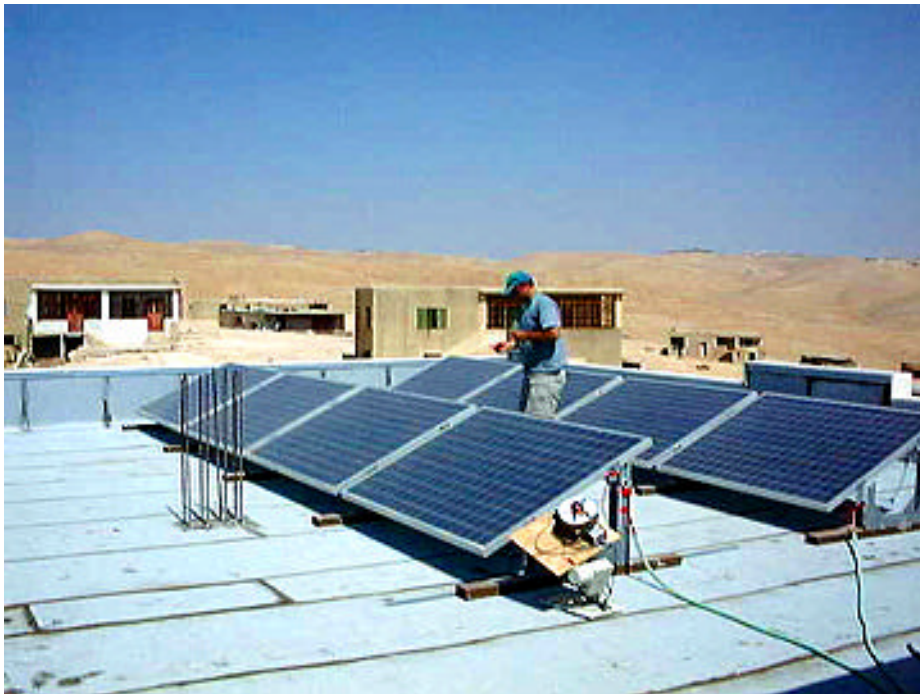
The system consists of two strings of four ASE 300-DGF/17 modules, each string having its modules connected in series. The modules face due south at a tilt angle of 25° to the horizontal. Two cables (one from each string) descend from the roof and feed an inverter / battery-storage system. **Fig.1** shows the array as presently positioned on the roof-top of the school.

Figure 1: The roof-mounted PV array at Al Kaabneh high school. Modules shown (left to right) are: back row, “A” through “D”; front row; “E” through “H”. (See Table 1)

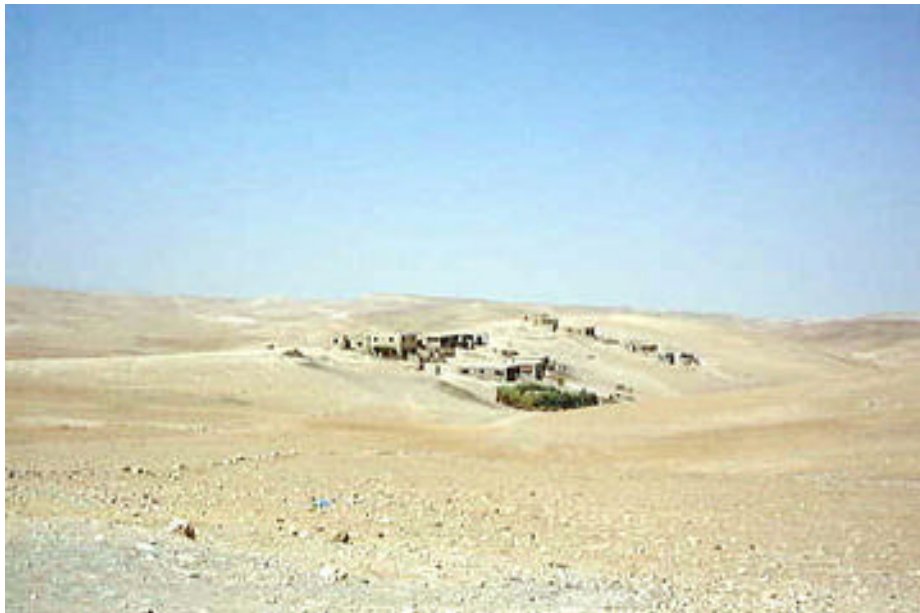
Measurement conditions were as near perfect as could be desired since there was a cloudless blue sky from the time of our arrival at the site, around 10 am Summer Time [corresponding to 9 am Israel Standard Time (IST)], through the noontime, IST, period during which measurements were made. Wind speed was unmeasurably small. **Fig.2** is a photograph of the village, taken as we were about to depart in the late afternoon. One sees that the sky was still cloudless at that time.

Figure 2: Clear sky over the village of Al Kaabneh

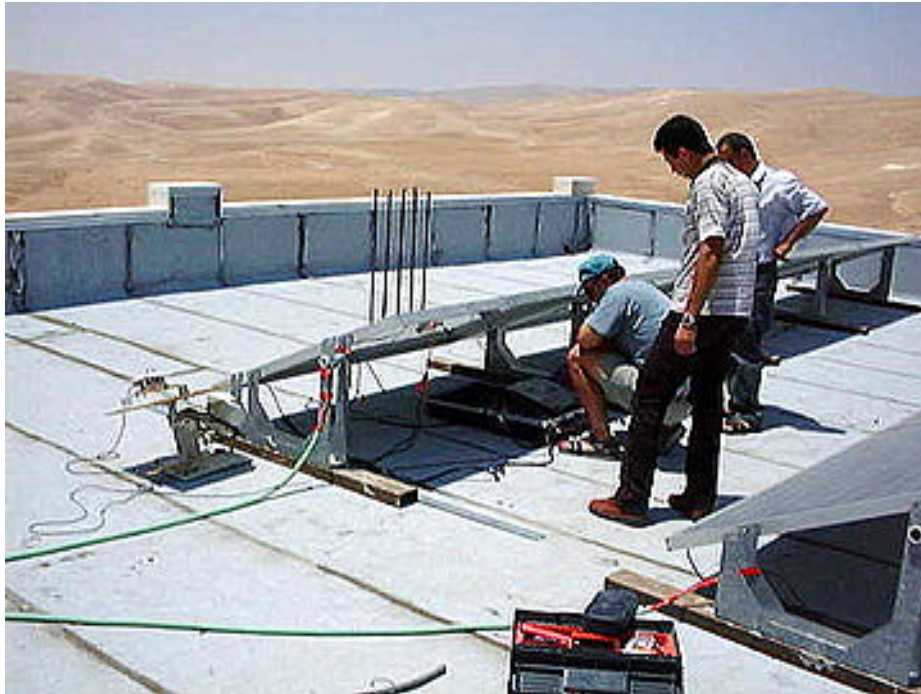
The pyranometer was then re-adjusted to the angle of the system array and eight I-V curves were taken, one for each of the modules in the array. See **Fig.3**.

Figure 3: The process of I-V curve measurement for module “H”. The plane-of-array pyranometer is seen on the left of the picture.

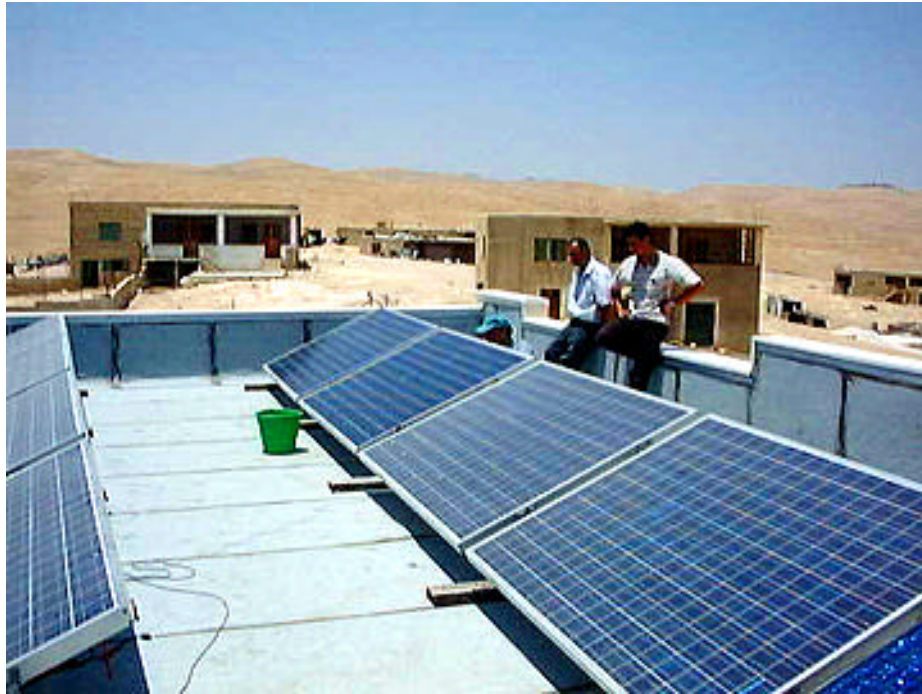
Two of the modules, “A” and “B” (see **Table 1**) were then cleaned (**Fig.4**) and re-measured. One of them, “A”, was subsequently moved from its stand and measured under conditions of normal incidence.

Figure 4: Modules “A” and “B” after cleaning, compared with “as is” neighboring modules

Comparison of **Tables 5A** and **5B** with the corresponding **Tables 4A** and **4B** indicate that dirt on the modules was responsible for an approximately 5% lowering of system performance. We have no way of knowing when, if at all, the modules had been cleaned prior to these measurements; however, the ease of access to the modules suggests that periodic cleaning should present no problem.

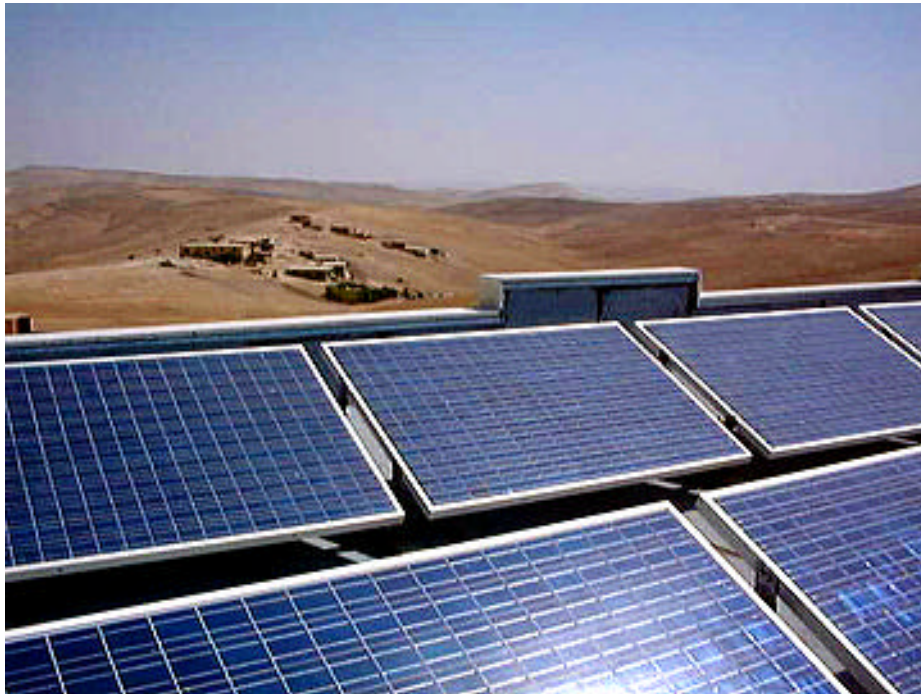
Figure 5: Modules “A” (background) and “E” (foreground) are located too close (i.e. approximately 47 cm) to the western roof parapet (of height 72 cm above roof level). Afternoon shading by the latter will impair array performance. [Further dimensions will be found in **Table 6**]

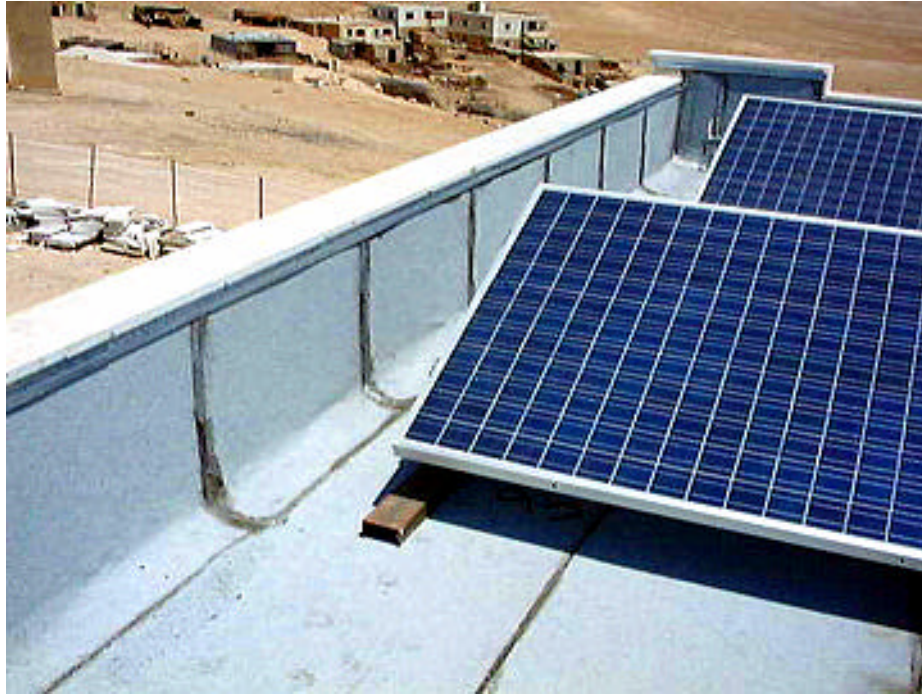
Height above roof-level of tops of southern and western parapets	72 cm
Distance between western parapet and western edge of array	47 cm
Height above roof level of lower edge of modules	23 cm
Height above top of parapet of upper edge of array	6 cm
Distance between southern parapet and lower edge of modules in south row	300 cm
Gross width of each module	189 cm
Gross length of each module	128 cm
Module tilt angle relative to the horizontal	25°
Site Latitude	31° 24' N
Site Longitude	35° 12' E

4. We should also report on two slight installation oversights, both of which are easy to rectify. First, the west side of the PV array is located too close to the roof parapet (See **Fig.5**). The latter will cast an afternoon shadow, particularly in winter, which will result in a serious decrease in short-circuit current for the array. The entire array should be shifted eastward by approximately 1-2 meters. **Table 6** lists some relevant dimensions and angles will enable the precise shift required to be calculated.
